## PXE-100 Lid Latch Replacement

Kit Numbers 92484

To replace a broken lid latch on Velocity fryers.

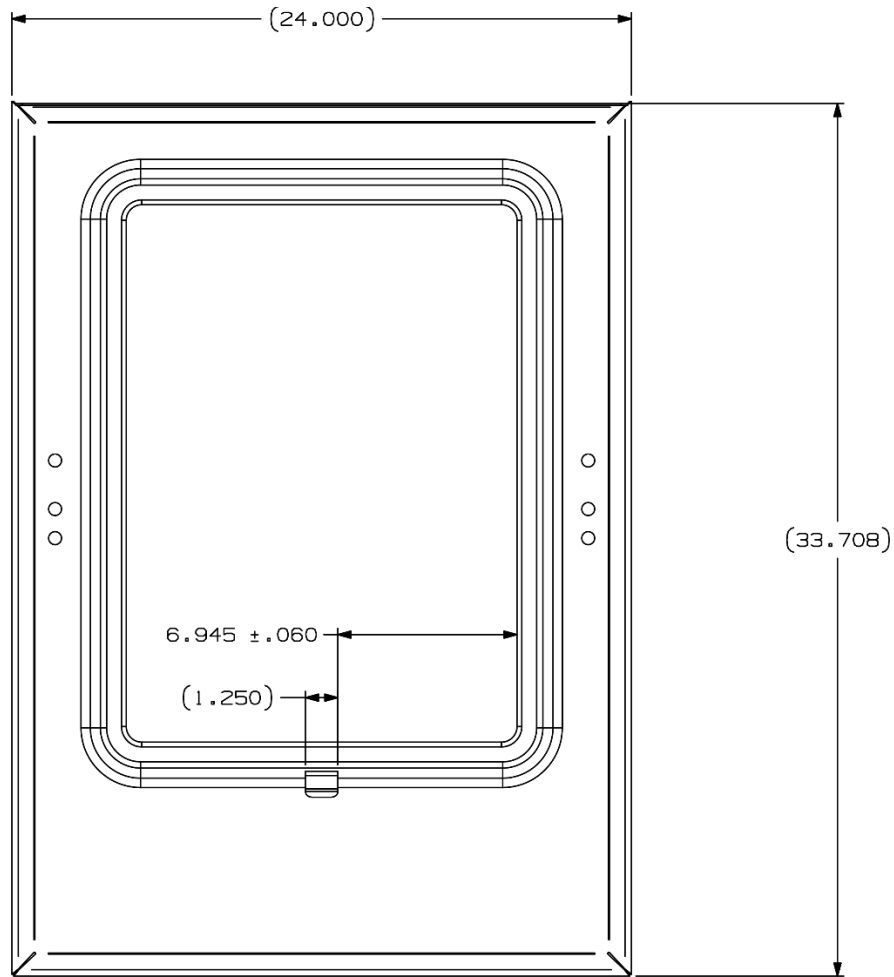
**Figure 1**

- 1 Using an angle grinder, grind off the remains of the existing catch clip.
- 2 Using a degreasing agent, clean the front of the pot band.

- 3 Using a marker, mark the horizontal location of the new catch clip. Clip should be centered with  $6.945 \pm .060$  inches on either side. See **Figure 1**.
- 4 Using a marker, mark the vertical location of the new catch clip. Bottom of clip should be positioned  $1.345 \pm .020$  inches from top of countertop. See **Figure 2**.

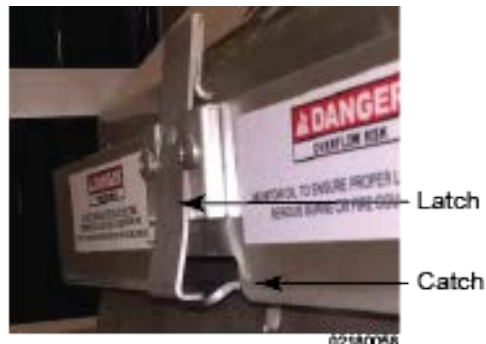
**Figure 5**

**NOTICE:** The lid latch to catch engagement should be smooth and not clunky. The lid latch should gently but firmly slide over the catch and engage without excessive play. If the lid must be slammed to lock, the engagement is too tight. If clip is not adjusted properly, damage to the clip may occur.

- 9 Open and close the lid while inspecting the lid latch and catch for engagement.
